PATRIOT HOME INSPECTING LLC

## HOME INSPECTION

1234 Main Street  
Shelbyville, KY 40065

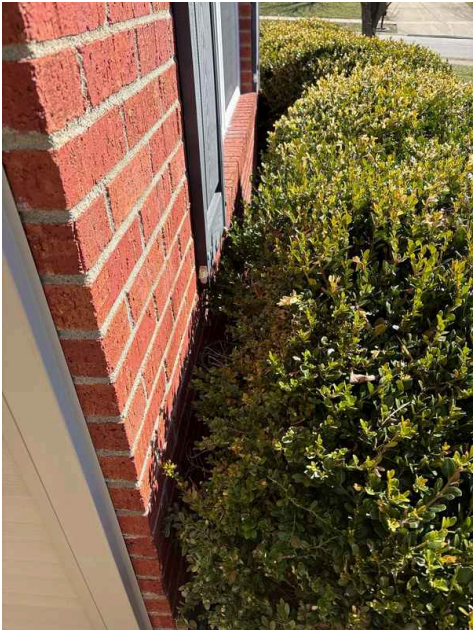
#### 2.1.1 Site Conditions

There is vegetation in contact with the house. This condition can damage siding over time, allow the areas to hold moisture and give easy access for wood destroying insects to enter the home. Recommend trimming trees/vegetation, so it doesn't come into contact with the home.

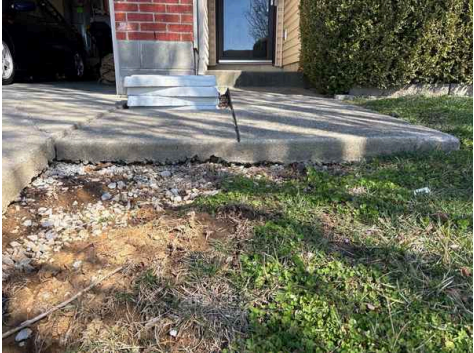
#### 2.2.1 Walkways & Driveways

#### UNEVEN SLABS

There are uneven slabs at the walkways, which could be a tripping hazard. Recommend using additional caution in these areas and having repaired or replaced as needed.

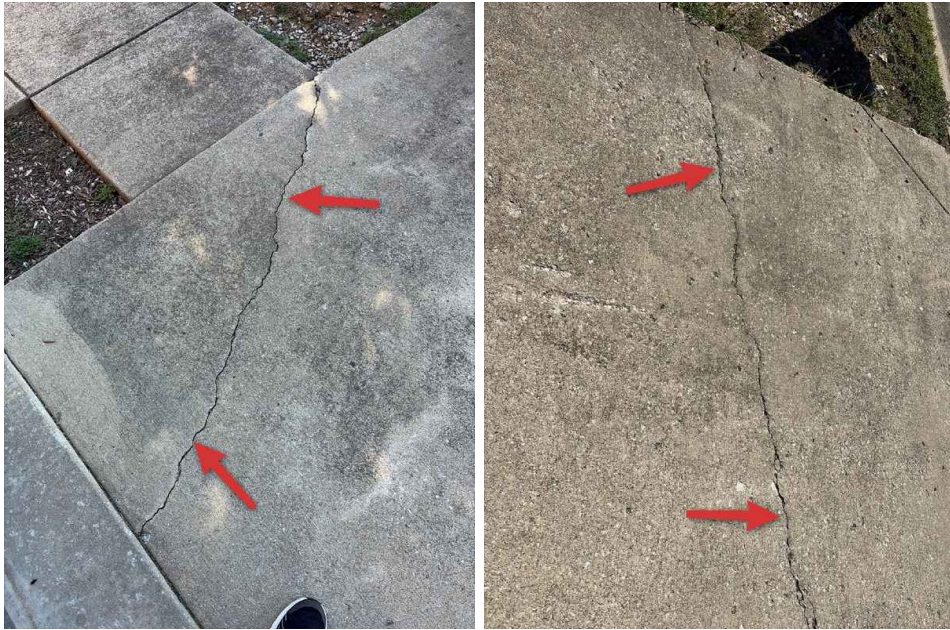
#### 2.2.2 Walkways & Driveways

#### TYPICAL CRACKING

The driveway had some typical cracking/chipping but is usable. Recommend sealing the cracks to help prevent additional damage and monitor.

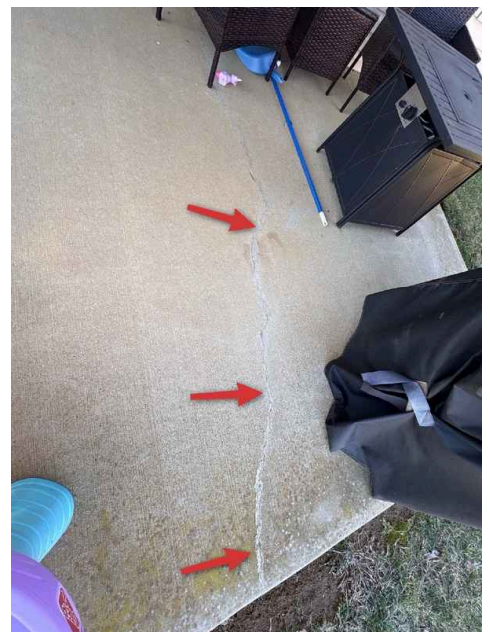
### 2.3.1 Porches, Patios, Stoops & Steps

#### **CRACK THROUGH PATIO**

A crack extends completely through the patio surface. Water can penetrate through this crack, leading to further deterioration, potential sub-base damage, and expansion of the crack over time. The crack should be properly sealed to prevent water intrusion and monitor for any worsening. Contact a licensed professional if needed.

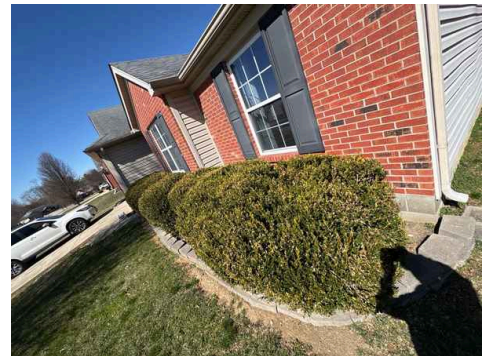
**LIMITED VISIBILITY DUE TO VEGETATION**

There is at least one area with limited access to the siding, due to vegetation, on the exterior of the home. There may be defects present that were not visible or identified. Recommend a qualified specialist trim back and/or remove vegetation so that the siding can be properly inspected.

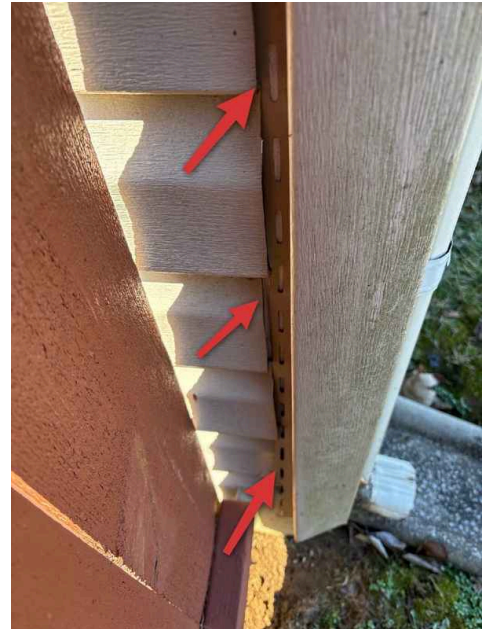
### 3.3.1 Trim

#### DETACHED TRIM

There is at least one area of detached trim on the exterior of the home. Further damage may occur if left in this condition. Recommend a qualified specialist make all necessary repairs.

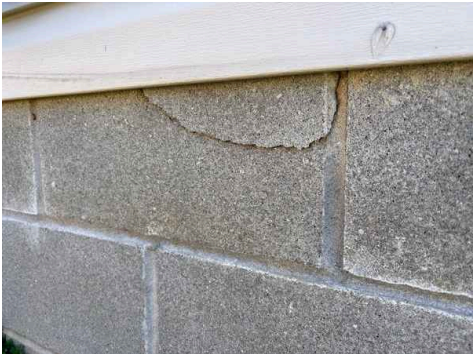
3.7.2 Foundation Walls

**CHIPPED CONCRETE MASONRY UNIT**

A localized chip was observed on the exterior concrete masonry unit (CMU) block during inspection. This may allow moisture penetration if left unaddressed. Recommend sealing/repairing the damaged area and monitoring for further deterioration.

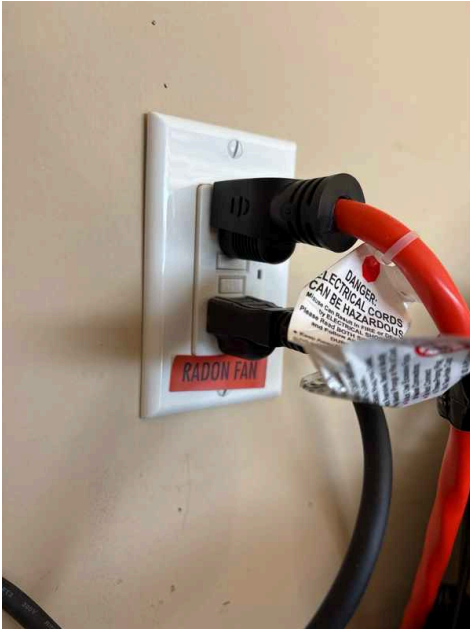
The radon mitigation system is not part of the home inspection. However, the blower motor is plugged into a GFCI protected receptacle. In the event of this GFCI receptacle being tripped, the radon mitigation system would not be operational which is a safety concern. Recommend a licensed electrician install a dedicated circuit for added safety.

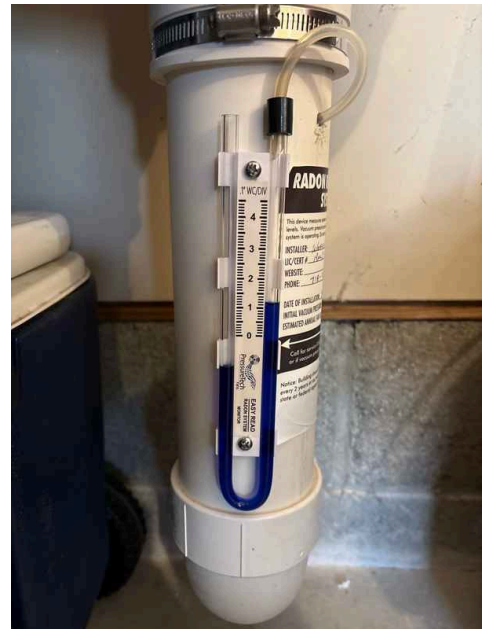
### 3.12.3 Radon Mitigation System

#### **RADON REDUCTION FAN INDICATOR**

Radon Reduction Fan Indicator. This gauge is an indication of fan performance. Significant change may indicate a system performance malfunction. Recommend monitoring and consulting a professional Radon Installation Contractor as needed.

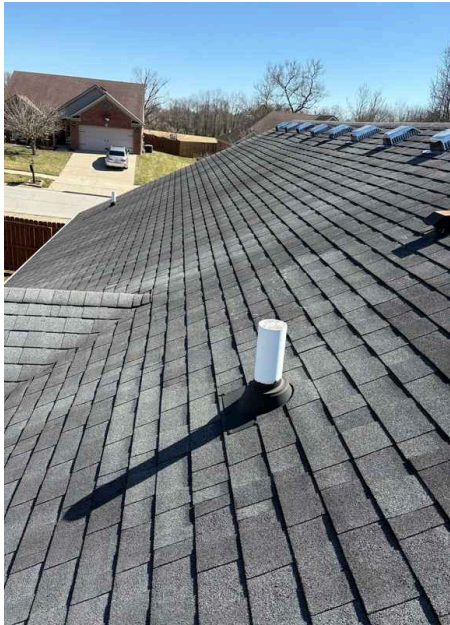
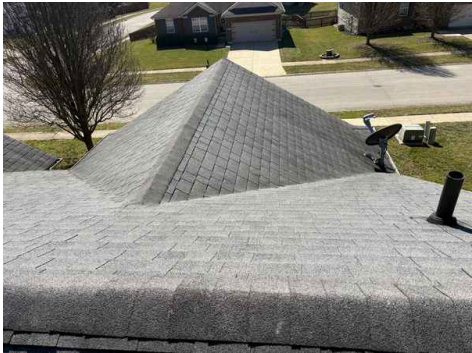
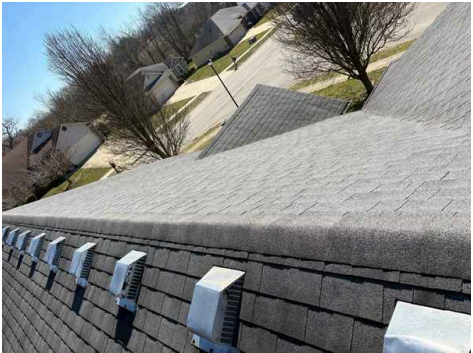
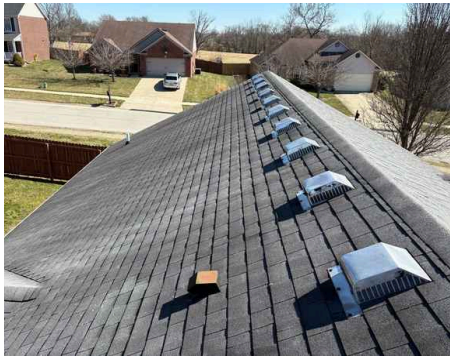
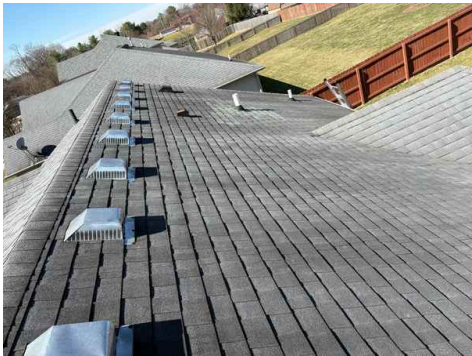
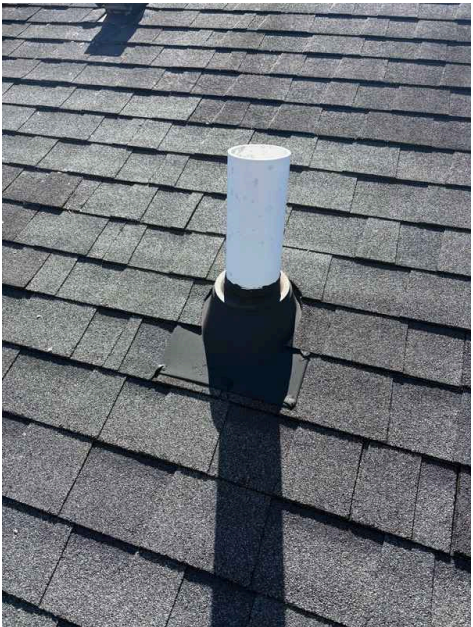
Roof Covering: Pictures

| <b>Roof Covering: Roof Age &amp; Layers</b><br>Approximate Age: 16-20+ years,<br>Layers: 1+ | | |

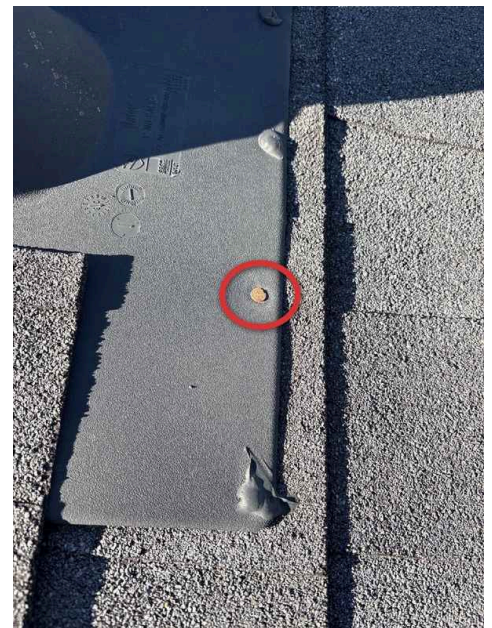
#### EXPOSED FASTENERS

There are exposed nail heads securing the flashing to the roof. Exposed nail heads can allow water to penetrate the roof. Recommend a licensed roofer to seal the nail heads.

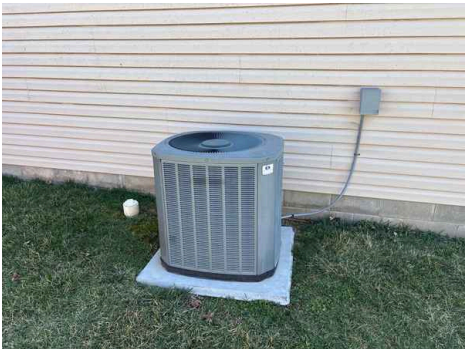
| <b>Location</b><br>Left side of home | <b>Unit Type(s)</b><br>Air Conditioner | <b>Manufacturer(s)</b><br>Trane |
| <b>Energy Source(s)</b><br>Electric | <b>Outside Disconnect</b><br>Yes | <b>Approximate Age</b><br>16-20+ years |
| <b>Maximum Breaker Rating From Data Plate</b><br>30 Amps | <b>Breaker Installed in Panel Box</b><br>30 Amps | <b>The Exterior HVAC Unit View</b><br> |

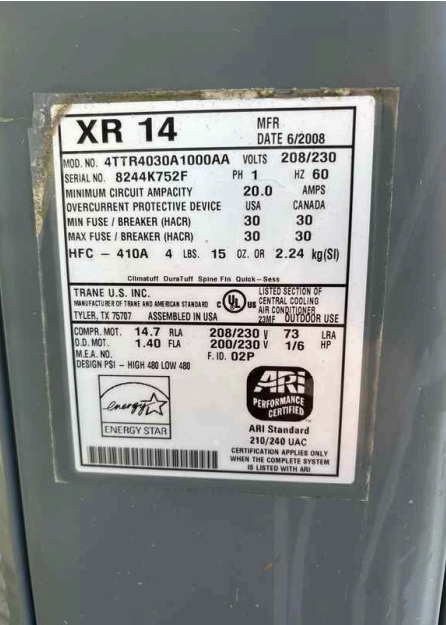
### Data Plate with Model and Serial Numbers

This photo is the Air Conditioner Compressor/Condenser Data Plate with Model and Serial Numbers.

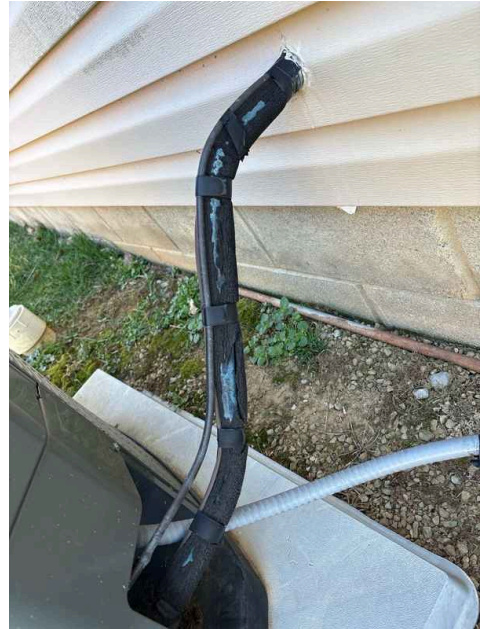
## 5.1.2 Condition

**INSULATION DAMAGED/MISSING**

There is damaged and/or missing insulation on the air conditioner refrigerant line. Recommend replacing insulation.

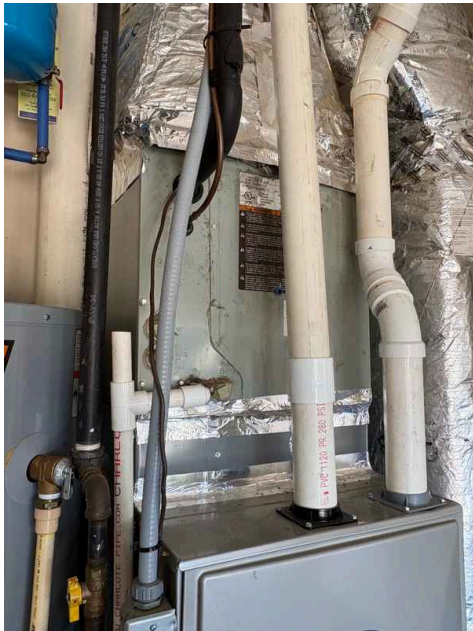
### UNIT TAPED UP - NOT INSPECTED

The condition of Evaporator coil/Fins is unknown, inside the unit is not accessible. Unit is insulated/taped up. Inspectors are not expected to carry metal duct tape to reseal seams that would be broken if unit was made accessible. There may be defects present that were not visible. Recommend a qualified licensed HVAC contractor evaluate, and make necessary repairs as needed.

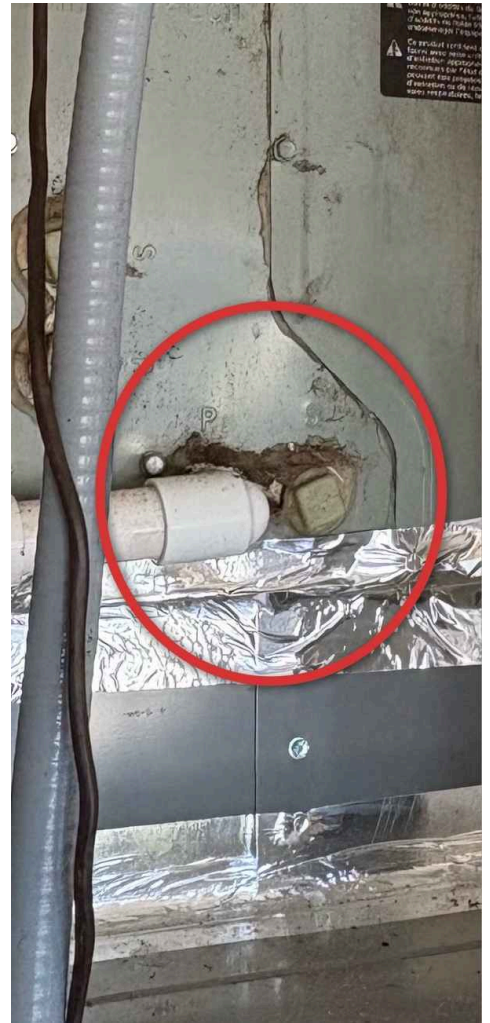
## 6.5.1 Condensate Line(s)

**NO SECONDARY CONDENSATE PROTECTION**

There is no secondary condensate protection installed on the air conditioner evaporator coil drain. This is a common practice, however, we recommend a licensed HVAC contractor install a secondary protection switch to help prevent damage to the furnace in the event that the drain becomes clogged and overflows.

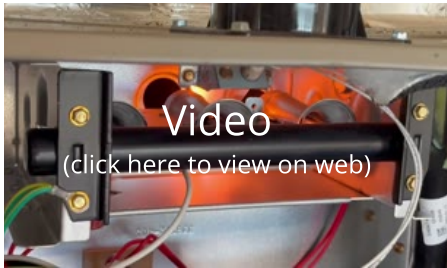
**Operation: Gas Furnace Operating**

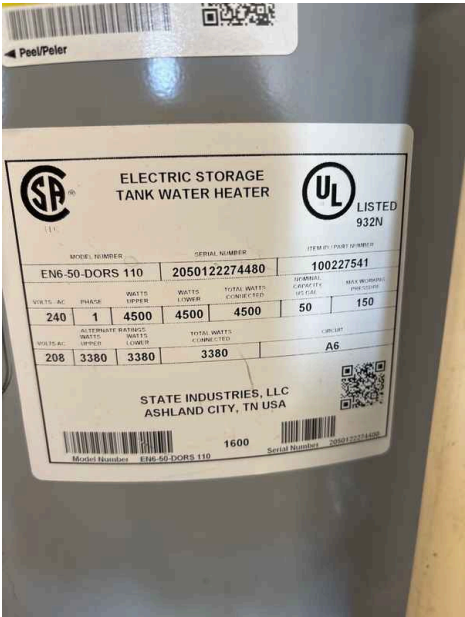
| <b>Location</b><br>Garage | <b>Manufacturer</b><br>State | <b>Energy Source</b><br>Electric |
| <b>Capacity</b><br>50 gallons | <b>Approximate Age</b><br>6-10+ years | <b>Data Plate with Model and Serial Numbers</b><br><br>This photo is the Water Heater Data Plate with Model and Serial Numbers. |

**Safety Controls: Disconnect**  
Not Present; but the water heater is in sight of the panel box

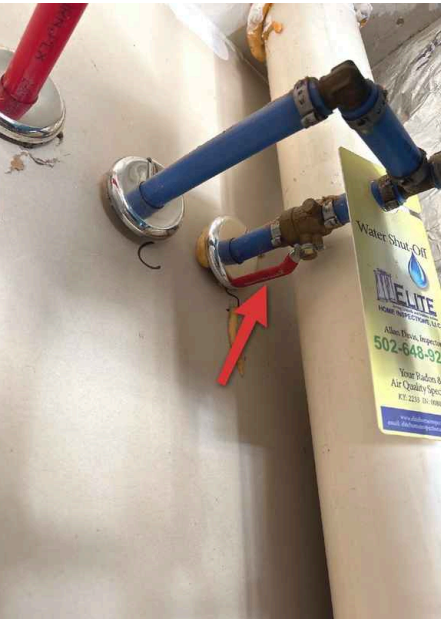
| <b>Main Water Supply Entry: Water Supply Type</b><br>Public from Utility Company | <b>Main Water Supply Entry: Material</b><br>PEX Plastic | <b>Main Water Shut-off: Location</b><br>In the garage |
| <b>Main Water Shut-off: Main Water Shut-off View</b> | <b>Visible Water Distribution: Material</b><br>PEX Plastic | <b>Fixtures: Functional Flow</b><br>Yes |

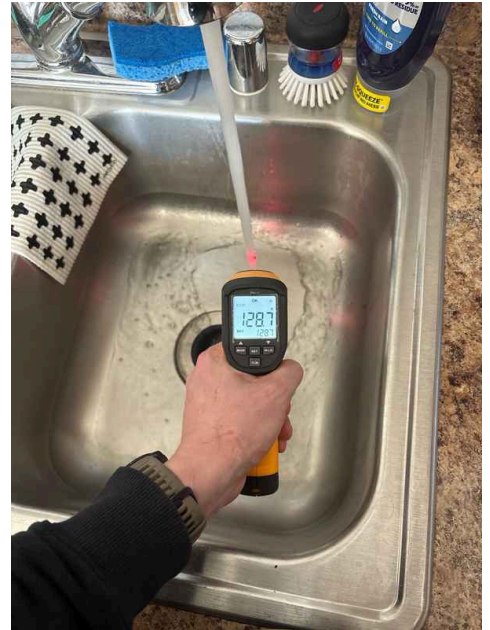
The water temperature is over 120 degrees, which is a scalding hazard. Recommend reducing the temperature to 120 degrees. Consult a professional contractor as needed.

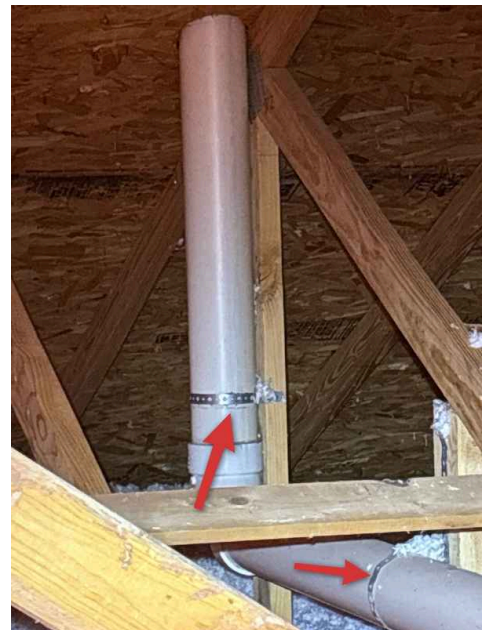
### 10.5.1 Visible Drain/Waste/Vent Piping

#### PLASTIC DWV PIPING SUPPORTED W/ METAL HANGERS

Some plastic drain piping, as seen in the unfinished areas of the home, are supported with metal hangers. Metal hangers can damage the plastic piping over time. Recommend replacing the metal hangers with proper plastic hangers.

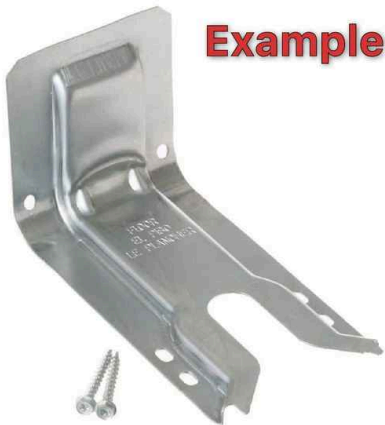
There is no anti-tip bracket installed. This is a Safety concern. Small children can be injured by sitting/standing on the oven door when it is open. The stove can fall over on top of them causing serious injuries. Recommend installing an anti-tip bracket. See attached image for example of a common style bracket.

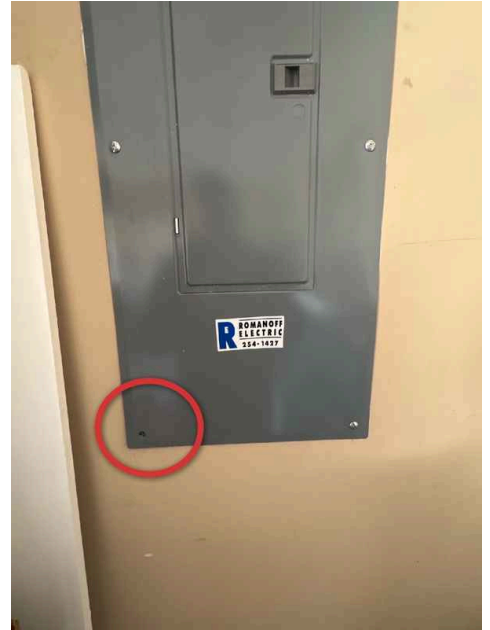
#### **PANEL COVER MISSING SCREWS**

The electrical panel cover was missing some screws. Recommend adding proper screws to secure panel cover.
