PATRIOT HOME INSPECTING LLC

HOME INSPECTION

1234 Main Street
Shelbyville, KY 40065

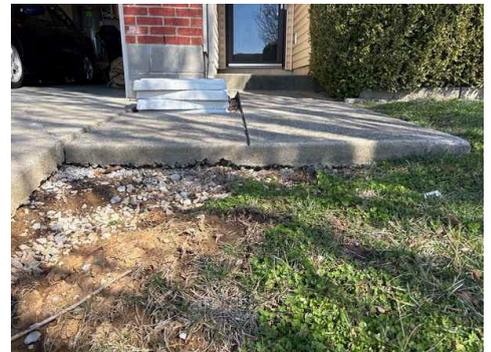
There are uneven slabs at the walkways, which could be a tripping hazard. Recommend using additional caution in these areas. Recommend licensed contractor repair or replace as needed.

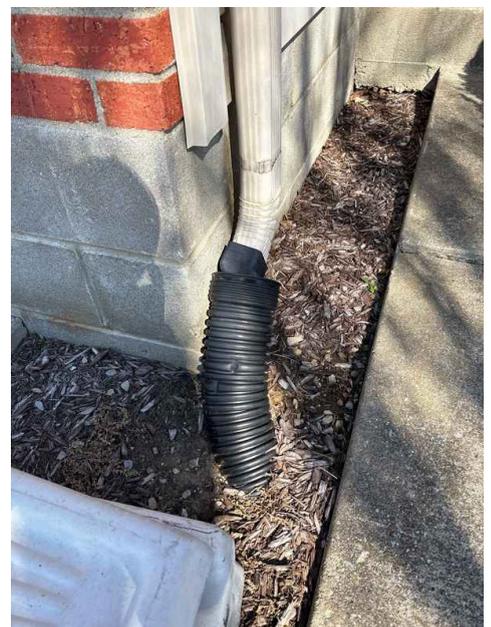
Siding

LIMITED VISIBILITY DUE TO VEGETATION

There is at least one area with limited access to the siding, due to vegetation, on the exterior of the home. There may be defects present that were not visible or identified. Recommend a qualified specialist trim back and/or remove vegetation so that the siding can be properly inspected.

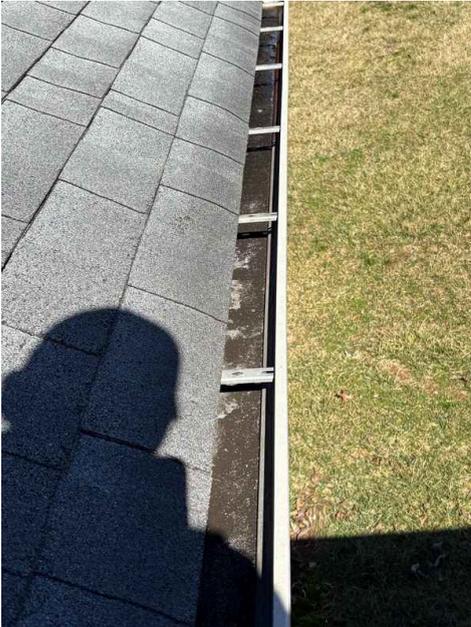
3.1.2 Gutters & Downspouts

STANDING WATER IN GUTTERS

There is standing water in the gutters in at least one location on the home. The gutters are not draining properly and damage may occur if left in this condition. Recommend a qualified guttering specialist make all necessary repairs.

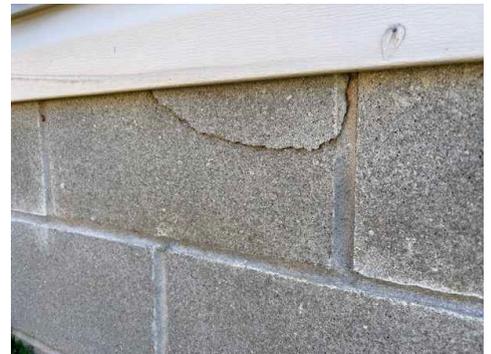
3.9.2 Foundation (Slab-On-Grade)

TYPICAL CRACKING FOUNDATION WALL

There is an area of typical cracking in at least one location to the exterior foundation wall. Recommend sealing cracks and monitoring. If the cracks get larger, or other cracking occurs, the client should consult with a qualified licensed contractor and/or a structural engineer to evaluate this condition and determine the appropriate course of action and make all necessary repairs. The client may wish to have further evaluation now.

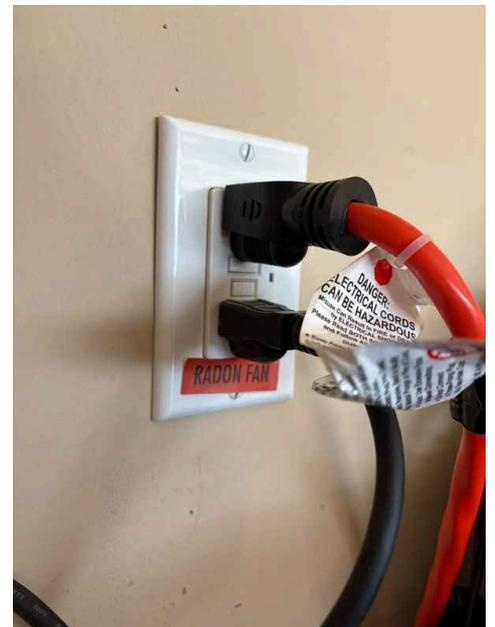
GFCI OPERATING RADON BLOWER MOTOR

The radon mitigation system is not part of the home inspection. However, the blower motor is plugged into a GFCI protected receptacle. In the event of this GFCI receptacle being tripped, the radon mitigation system would not be operational. Safety concern. Recommend a licensed electrician install a dedicated circuit for added safety.

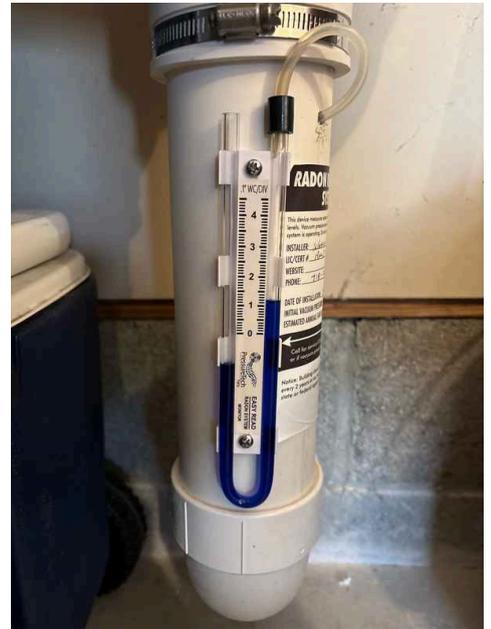
3.14.3 Building Exterior Wall Construction

RADON REDUCTION FAN INDICATOR

Radon Reduction Fan Indicator. This gauge is an indication of fan performance. Significant change may indicate a system performance malfunction. Recommend monitoring and consulting a professional Radon Installation Contractor as needed.

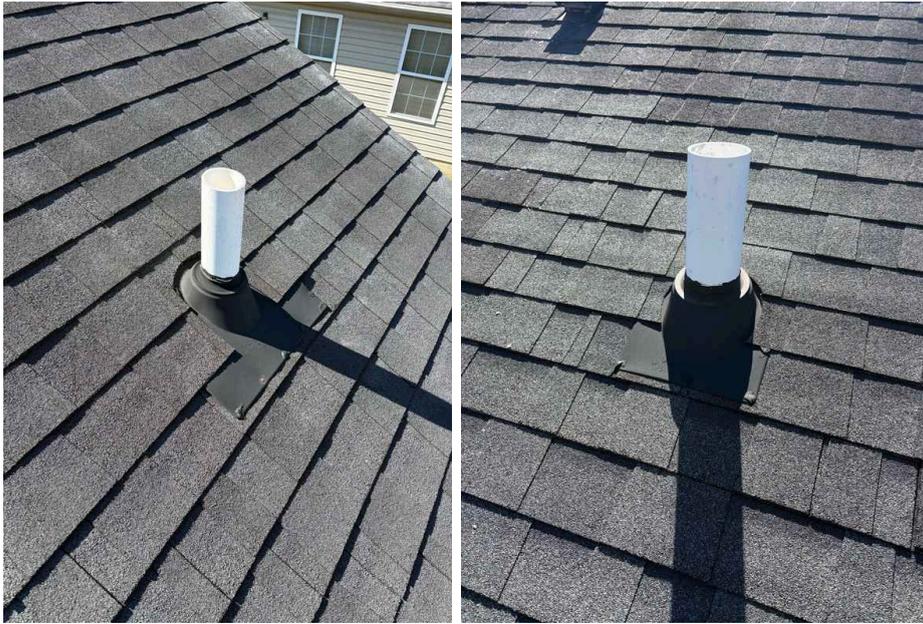
Mechanical Vents: The Plumbing Vent(s)

Mechanical Vents: Good Condition

The mechanical vents appeared to be in overall good condition with little or no deficiencies. Recommend yearly Inspections.

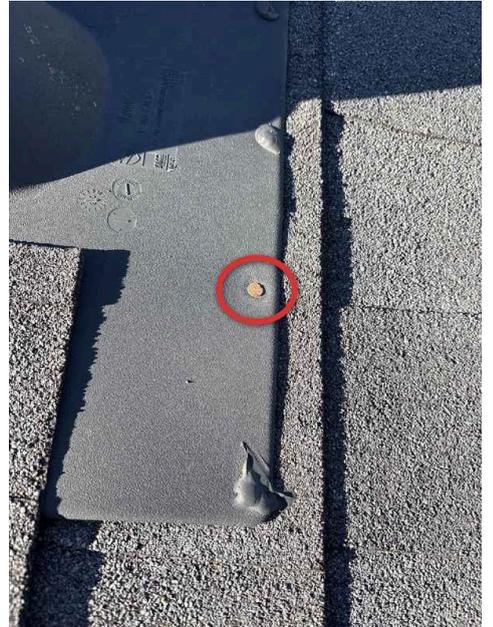
Minor Defect Repair / Replace**EXPOSED FASTENERS**

There are exposed nail heads securing the flashing to the roof. Exposed nail heads can allow water to penetrate the roof. Recommend a licensed roofer to seal the nail heads.

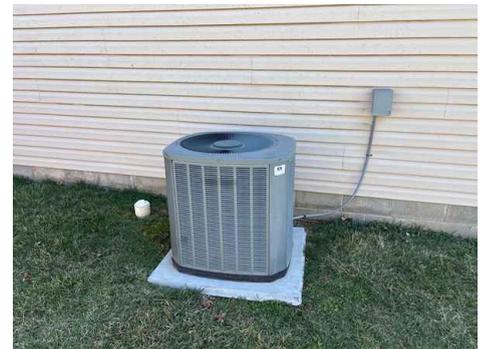
<p>Location Left side of home</p> <p>Energy Source(s) Electric</p> <p>Maximum Breaker Rating From Data Plate 30 Amps</p>	<p>Unit Type(s) Air Conditioner</p> <p>Outside Disconnect Yes</p> <p>Breaker Installed in Panel Box 30 Amps</p>	<p>Manufacturer(s) Trane</p> <p>Approximate Age 16-20+ years</p> <p>The Exterior HVAC Unit View</p>
---	--	--

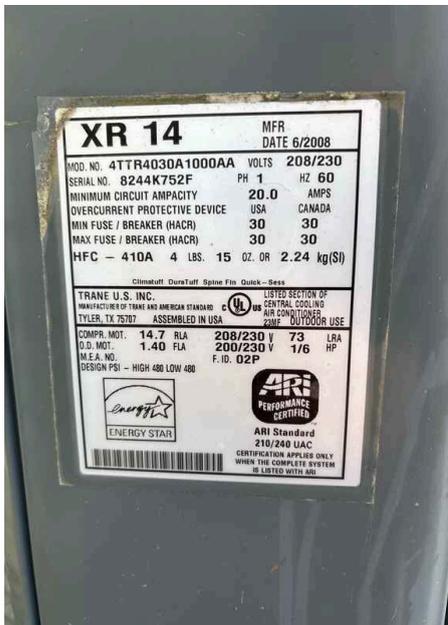
Data Plate with Model and Serial Numbers

This photo is the Air Conditioner Compressor/Condenser Data Plate with Model and Serial Numbers.

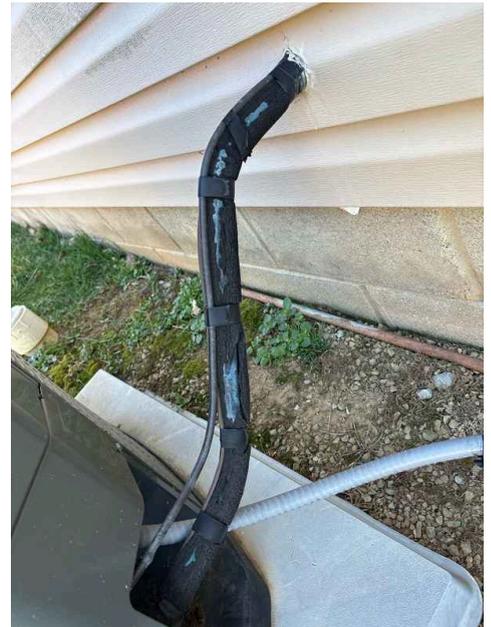
5.1.2 Condition

INSULATION DAMAGED/MISSING

There is damaged and/or missing insulation on the air conditioner refrigerant line. Recommend replacing insulation.

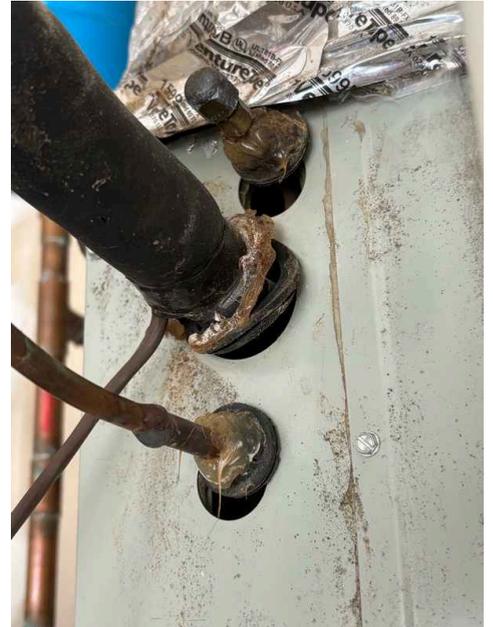
GROMMETS FOR REFEIGERANT LINES NEED ADJUSTMENT

The grommets that seal where the refrigerant lines enter the evaporator coil cabinet have been move from the knockouts. Recommend repair/replace

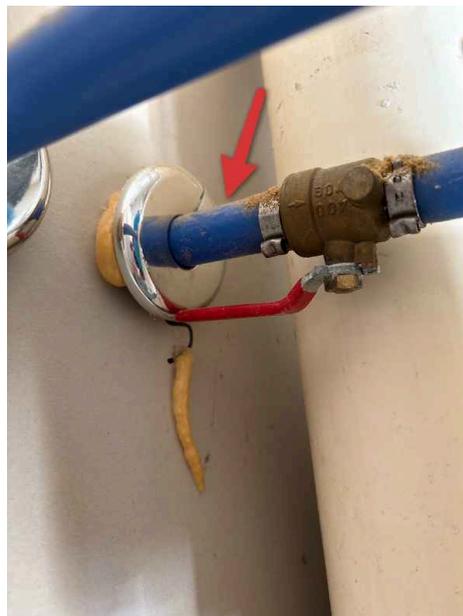
Main Water Supply Entry: Water Entry Piping View

Main Water Supply Entry: Material
PEX Plastic

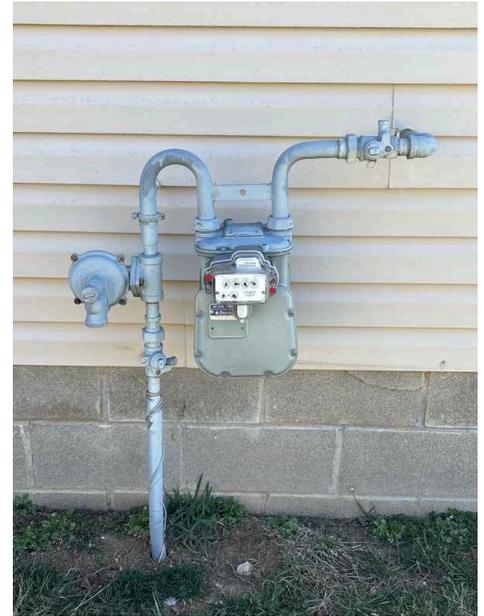
Fuel Storage & Distribution Systems: The Gas Meter View

Material: Black Iron

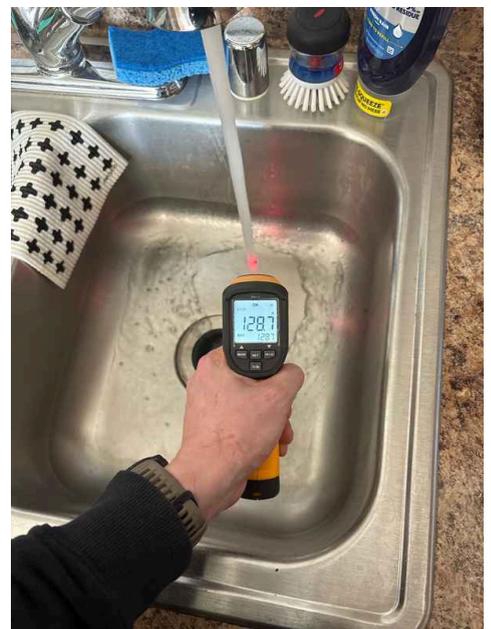
TEMPERATURE GREATER THAN 120 DEGREES

The water temperature is over 120 degrees, which is a scalding hazard. Recommend reducing the temperature to 120 degrees. Consult a professional contractor as needed.

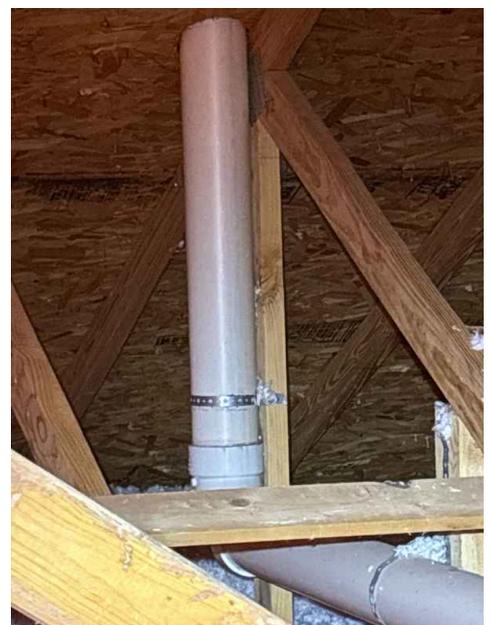
10.4.1 Visible Drain/Waste/Vent
Piping

PLASTIC DWV PIPING SUPPORTED W/ METAL HANGERS

Some plastic drain piping, as seen in the unfinished areas of the home, are supported with metal hangers. Metal hangers can damage the plastic piping over time. Recommend replacing the metal hangers with proper plastic hangers.

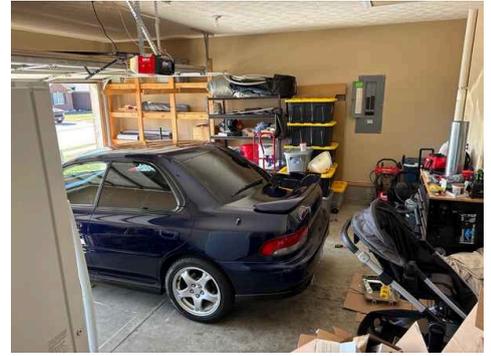
STORED ITEMS

The garage floor was covered with stored items. The floor could not be fully inspected. There may be hidden defects in the floor that the inspector could not examine. Recommend doing a final walkthrough before closing once the seller removes these items. Monitor and repair as needed.

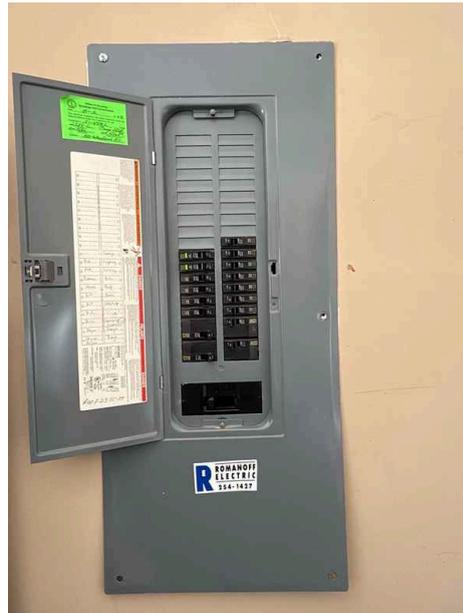
The Main Panel View

GFCI breaker installed: Yes, AFCI breaker installed: Yes, AFCI breaker operable: Yes

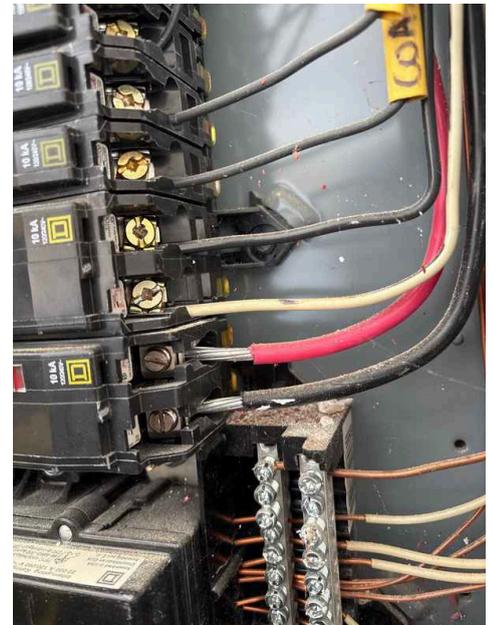
WHITE WIRE NOT PROPERLY IDENTIFIED AS HOT WIRE

There is at least one white distribution wire at the main electrical panel not properly identified for use as a branch circuit wire. Recommend a licensed electrician evaluate and repair.
